A Low-Power Arcjet Cyclic Lifetest

Francis M. Curran, Terry L. Hardy, and Thomas W. Haag
Lewis Research Center
Cleveland, Ohio

Prepared for the
1987 JANNAF Propulsion Conference
San Diego, California, December 15-17, 1987

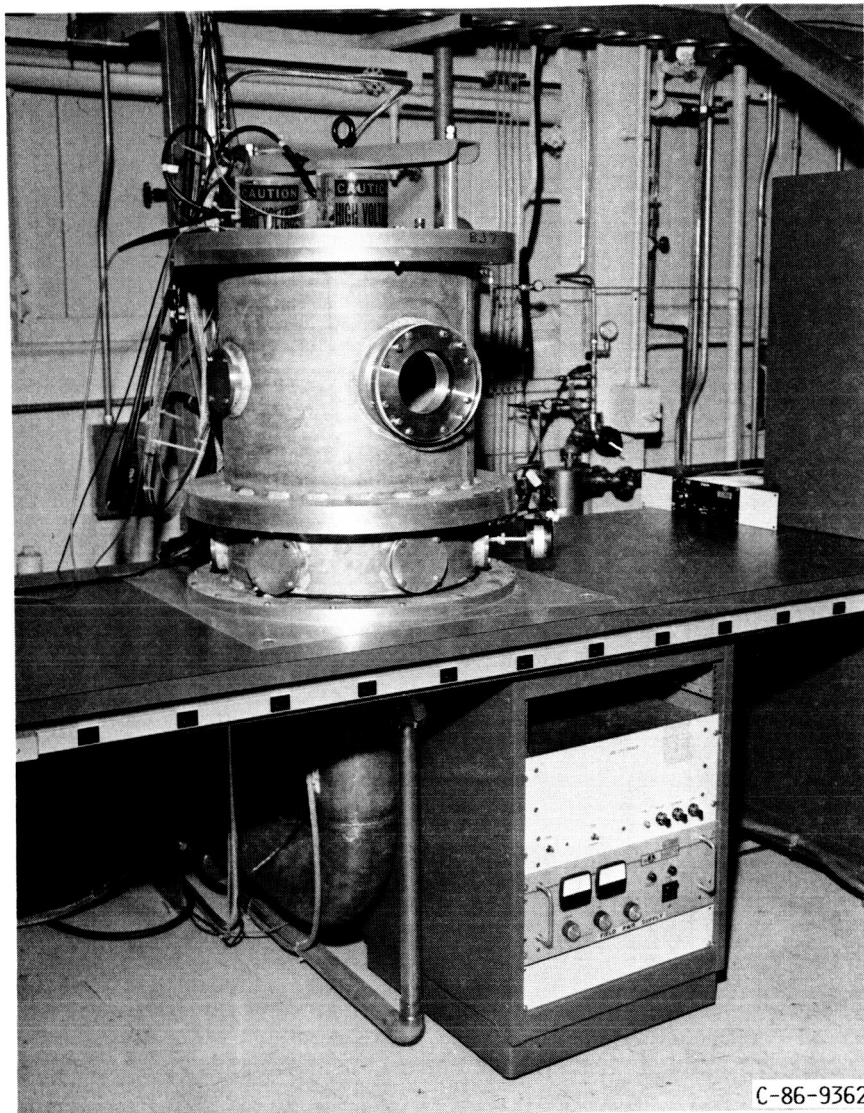
FIGURE 1. - VERTICAL BELL JAR BEST CHAMBER AND PULSE WIDTH MODULATED
POWER SUPPLY (BELOW).

The lifetest was performed in a small bell jar facility, shown in Fig. 1. This facility has been previously described in detail.¹³ Briefly, the dimensions of the chamber are 0.64 m in length and 0.64 m in diameter, and it was serviced by a single mechanical roughing pump with a pumping speed of 17 000 l/min. at 1 torr (133 Pa). In operation, an ambient pressure of approximately 0.75 torr (100 Pa) was maintained at the mass flow rate of the hydrogen/nitrogen mixture used in the test (4.07×10^{-5} kg/sec). The hydrogen/nitrogen mixture ratio was 2:1. A previous study has shown that the arcjet has the same voltage current characteristics at this level of background pressure as it does in high vacuum facilities.¹³ Commercially available mass flow controllers were used to

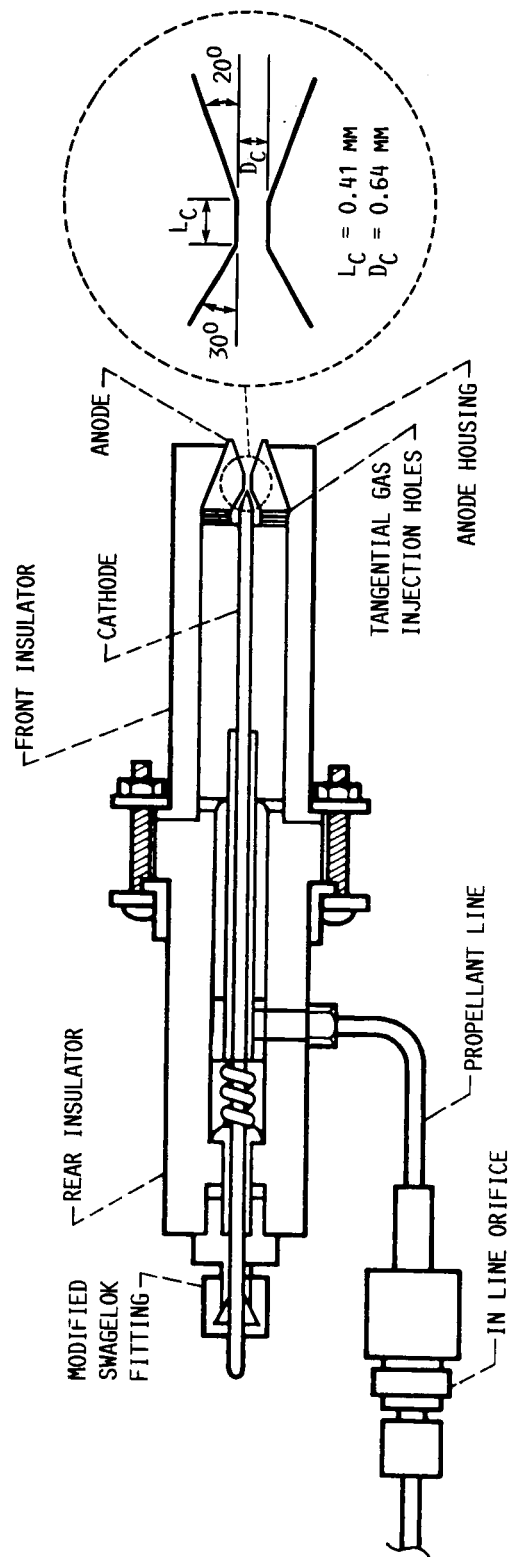
FIGURE 2. - CUTAWAY VIEW OF ARCJET THRUSTER WITH ANODE DIMENSIONS DESCRIBED.

The arcjet used throughout the test was of the conventional, constricted-arc design. A cross-sectional schematic is shown in Fig. 2. The anode housing was made of titanium-zirconium-molybdenum (TZM) and the rear insulator of boron nitride. Graphite foil seals were used on critical surfaces. To improve the sealing capability, a shallow spiral groove was machined into the rear sealing surface on the anode housing. Two molybdenum flanges, a stainless steel collar, and four bolts were used to hold the rear insulator and the anode housing together. The anode/nozzle insert, illustrated in the figure, was made from two percent thoriated tungsten. The converging and diverging sides of the nozzle were both conical with half angles of 30 and 20°, respectively. The constrictor was 0.41 mm in length and 0.64 mm in diameter. A photomicrograph of the converging side of the anode with a view down the constrictor is shown in Fig. 3. The diverging side was similar in appearance.

To provide the vortex flow pattern used to stabilize arcjet operation, a molybdenum gas injection disk with graphite foil gaskets on either side was inserted into the housing to seat against the insert on one side. The two tangential injection holes in the disk were nominally 0.34 mm in diameter. Raised ridges were machined on both of the disk faces. These ridges compressed the graphite foil to provide a gas-tight seal when the entire unit was assembled. Immediately upstream of this disk was the front insulator. This was also made of boron nitride and had both a centered hole for the cathode and grooves milled on its exterior surface to allow gas passage. A larger bore was used in the rear (upstream) of this insulator to accommodate an aluminum oxide tube, used to isolate the cathode from surfaces at anode potential.

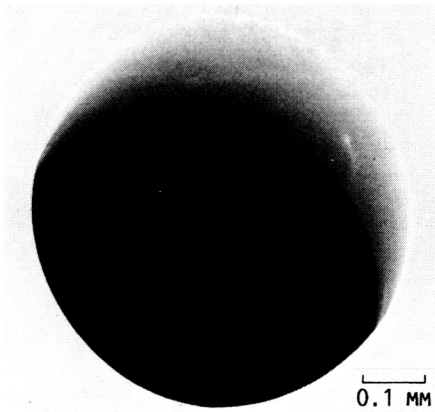
FIGURE 3. - PHOTOMICROGRAPH OF CON-
VERGING SIDE OF ANODE WITH VIEW
DOWN CONSTRICTOR.

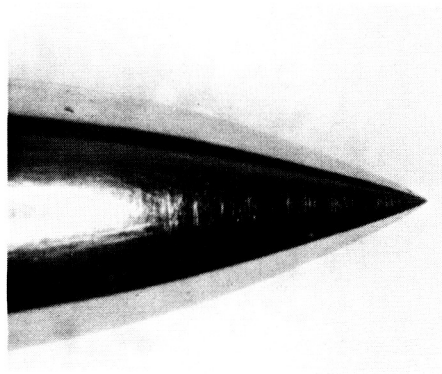
FIGURE 4. - PHOTOMICROGRAPH OF
CATHODE TIP BEFORE TESTING .

The cathode was made from 2 percent thoriated tungsten rod, 3.2 mm in diameter and approximately 190 mm in length. The tip was initially ground to a 30° half angle and then polished to remove any rough edges and give the cathode tip a bullet shape as shown in Fig. 4. A stainless steel cathode holder was used to feed the cathode through the rear insulator and locked the cathode in place once the arc gap was set. The aluminum oxide tube extended nearly to the cathode holder and, from back

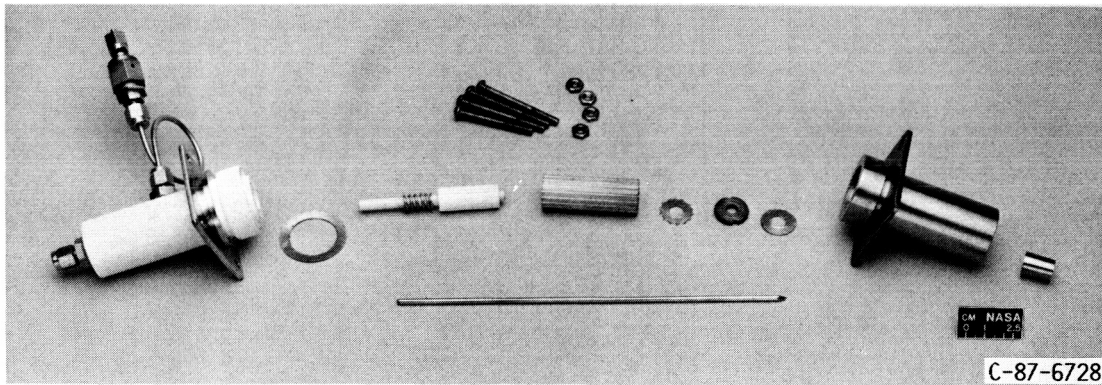
FIGURE 5. - DISSASSEMBLED THRUSTER BEFORE START OF LIFE TEST.

A photograph of the arcjet engine prior to assembly is shown in Fig. 5. The arc gap was set by moving the cathode forward until it contacted the anode, measuring the entire unit, withdrawing the cathode the desired distance, and then tightening the modified compression fitting. The gap was set to 0.58 mm.

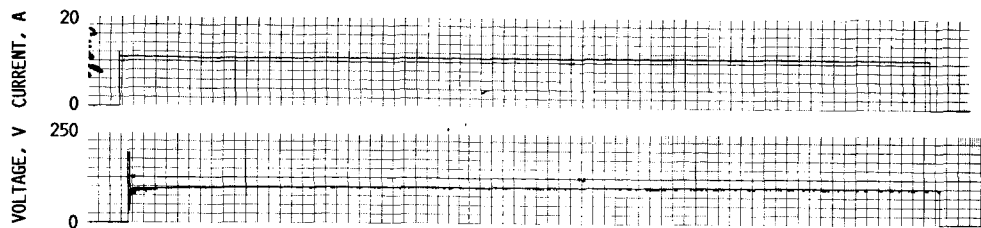
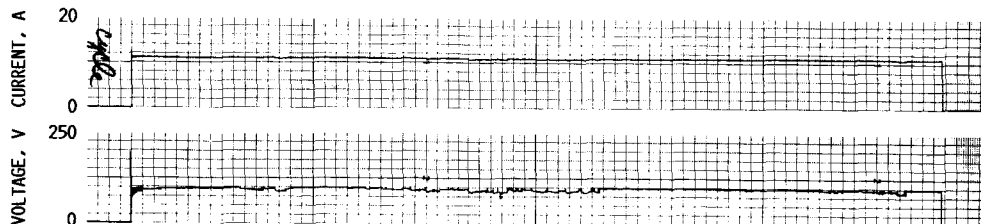
(A) CYCLE 9 - RAPID ARC VOLTAGE EXCURSIONS.

(B) CYCLE 13 - STEP CHANGES IN ARC VOLTAGE.

FIGURE 6. - VOLTAGE AND CURRENT TRACES SHOWING VOLTAGE EXCURSIONS DURING BURN-IN-PERIODS.

Laboratory experience has shown that the operational stability of the arcjet is manifested in the steadiness of the plume and the smoothness of the voltage trace. After a performance check of the assembled thruster, a 14 cycle burn-in period was carried out before consistent arcjet operation was obtained. While some of the cycles during this period showed stable voltage readings, a number were characterized by fluctuations in the voltage trace. Some of these were very rapid excursions such as those shown in Fig. 6(a), while others involved step changes in voltage, shown in Fig. 6(b). The excursions were accompanied by motion of the plume. While no positive explanation for these observations exists, it is the authors' opinion that they are due to motion of the arc initiated by changes in the location at which the arc seats on the cathode. In the case of the rapid voltage excursions, the changes in voltage were too fast for the strip chart to record. The step changes

involved voltage excursions of up to 15 V. In one case, the arc seated on the converging side of the anode insert at the beginning of a cycle. In this mode, the low-voltage limit was violated and the arcjet system shut down before any damage was done to the arcjet. A system reset resulted in a normal starting sequence. During the course of the 14 cycle burn-in period, the steady state operating voltage increased from an initial value of 96 V to approximately 101 V.

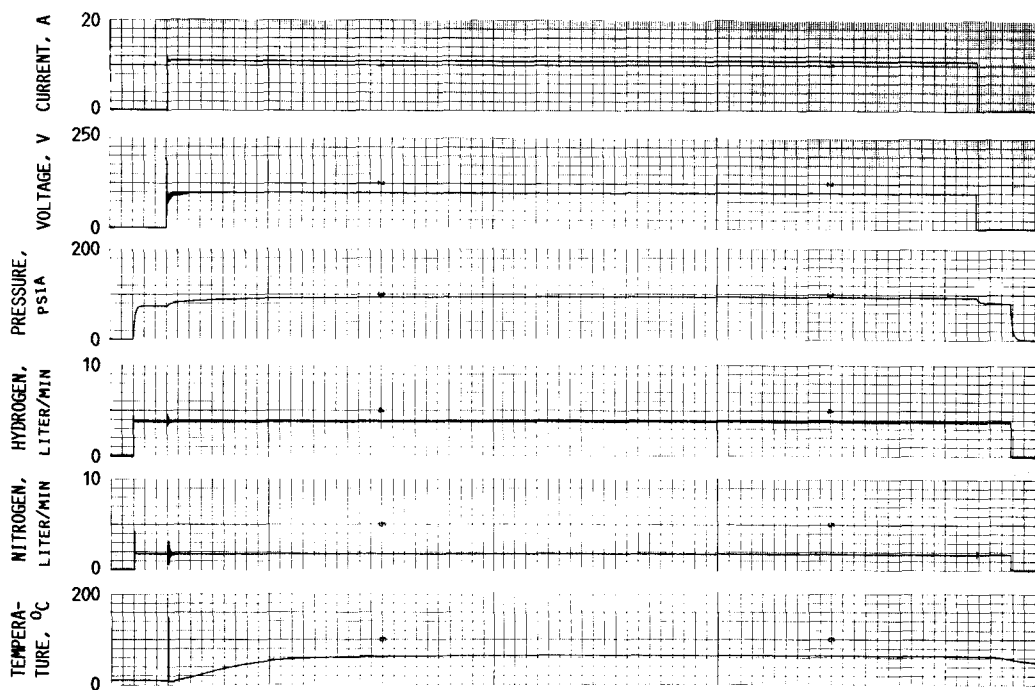
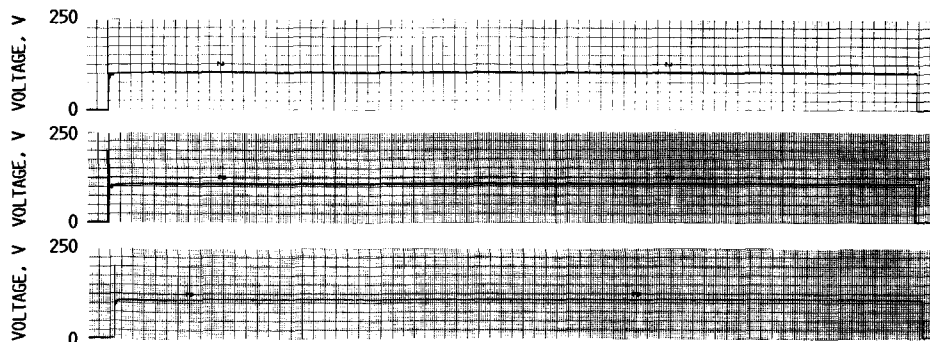
(A) STRIP CHART RECORD FROM LIFE TEST CYCLE 1 (POST BURN-IN).

(B) VOLTAGE TRACES FROM CYCLES 50, 100, AND 150.

FIGURE 7. - STRIP CHART RECORDS OF REPRESENTATIVE CYCLES THROUGHOUT LIFE TEST.

The first 300 hr of the lifetest following the burn-in period were characterized by very stable, consistent steady state operation of the arcjet, as demonstrated in Fig. 7. Figure 7(a) displays the strip chart record of the first cycle of the lifetest. The current, as expected,²¹ reached its steady state value almost instantaneously, while the arc voltage exhibited a brief period of instability (less than 5 min). This behavior is common to arcjet operation and is due to the fact that the arc does not immediately come to an equilibrium position on the tip of the cathode. The time required for arc stabilization varied from cycle to cycle but was never longer than that observed at the start of cycle 1. In all cases, the voltage was within 98 percent of its steady state value five minutes after ignition. As noted at the bottom of Fig. 7(a), temperature measured on the rear insulator was seen to rise slowly to a steady state value somewhat above 300 °C during the cycle from a precycle value of about 40 °C.

As discussed previously, variations in the arcjet operating characteristics are clearly manifested in the arc voltage readings. Fig. 7(b) shows the voltage traces from the 50th, 100th, and 300th cycles. These all display typical (short) starting transients followed by stable operation. Visually, no flickering or unsteadiness was observed in the plume during steady state operation. Taken together, these observations indicate that the arc seated in a stable repeatable fashion on both the anode and cathode throughout each test period. However, one problem developed at the start of the fourth cycle. Here, the power supply came on as anticipated, but the arcjet would not start. The high voltage pulse was examined with an oscilloscope and found to be distorted as shown in Fig. 8. The distortion took the form of an interruption in the voltage rise early in the pulse. This indicates the occurrence of a brief, pre-ignition, corona discharge which, upon closer examination, was visible near the flanges and bolts at the center of the thruster. Fortunately, the current drawn by the corona discharge (about 0.1 A) did not completely discharge the inductor in the starting circuit and the voltage continued to rise at the conclusion of the discharge. To continue testing, the energy available in the starting pulse was increased so that the maximum voltage attained following the corona discharge was sufficient to start the arc. This effect was definitely related to the high background pressure in the bell jar and has not been observed in high vacuum facilities. A similar occurrence was observed on cycle 60. Here, the arcjet ran full cycle but several pulses occurred before arcjet ignition was accomplished. Once again, the energy level was slightly increased, but the same phenomenon occurred upon the initiation of cycle 61. Following this, cycle breakdowns began occurring on the first pulse and rarely was more than one pulse required through the remainder of the test. In one instance, a non-distorted pulse of 4 kV was observed which did not start the arcjet.

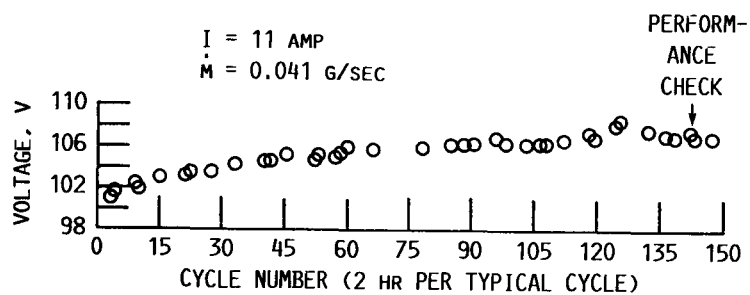
FIGURE 9. - ARC VOLTAGE VERSUS TIME AT CONSTANT CURRENT AND MASS FLOW RATE.

The steady-state voltage did increase during the life test from its initial value (cycle 1) of approximately 101 V, as shown in Fig. 9. The gradual rise in voltage totalled approximately 6 V over the 300 hr of operation. This rise was likely due to a gradual recession of the cathode tip. Though a constant voltage was not attained by the 150th cycle, the rate of increase in voltage was much greater through the burn-in period and in the first 75 cycles than it was in the last 75. The slightly elevated values observed around cycle 125 were due to a drift in the mass flow controllers. While this trend indicates that a final, steady value may eventually be achieved, cathode recession cannot be ruled out as a long term life limiting mechanism. Further testing of this thruster should provide a better understanding of this phenomenon. In any event, the cathode recession does not appear to cause problems through the first 300 hr of testing, although the increase in power at constant current will have to be addressed from a mission-impacts standpoint.

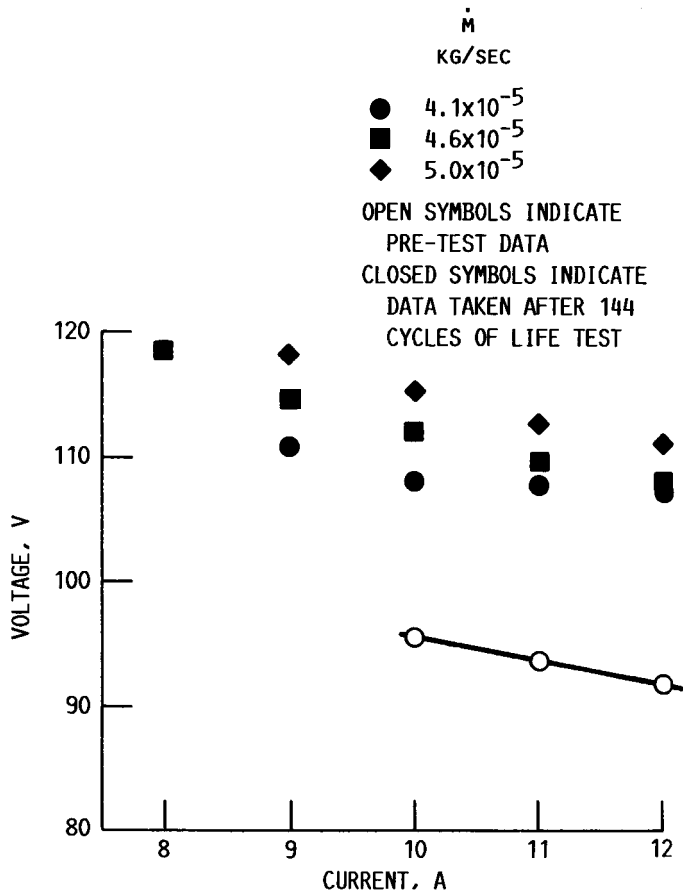
FIGURE 10. - VOLTAGE-CURRENT CHARACTERISTICS PRIOR TO TESTING AND AFTER 144 CYCLES OF THE LIFE TEST.

second test are collected in Table I. Figure 10 shows the voltage-current characteristics of the thruster under various conditions. The plot verifies that after 144 cycles, the thruster characteristics were very similar to those observed in prior tests of similar thrusters on hydrogen-nitrogen mixtures (for example, see Ref. 13). The gradual decrease in voltage with increasing current is due to the fact that, as the current increases, the arc core constricts and increases in temperature, thus increasing in conductivity.²⁴ The most important feature of the plot is the distinct contrast between the data taken at 144 hr and that taken before the lifetesting was begun. Once again, this demonstrates the need for a burn-in period to insure that no drastic changes in arc voltage and, therefore, power for a given current level occur at a given mass flow rate. This point is illustrated further by the data in Fig. 11 which plots specific impulse versus power for both sets of performance data. The pre-test data falls very close to that obtained at the later time indicating that the relationship of specific impulse to power at a fixed mass flow rate is reasonably constant even as the cathode tip recesses. The current necessary to attain a given power level, however, was higher in the initial test due to the lower voltages observed (approximately 10 V). In the case of a mission application in which maximum available spacecraft power must be used at all times to maximize specific impulse and thrust level, a power supply with a wide range of current capability would be necessary if a burn-in were not performed prior to flight.

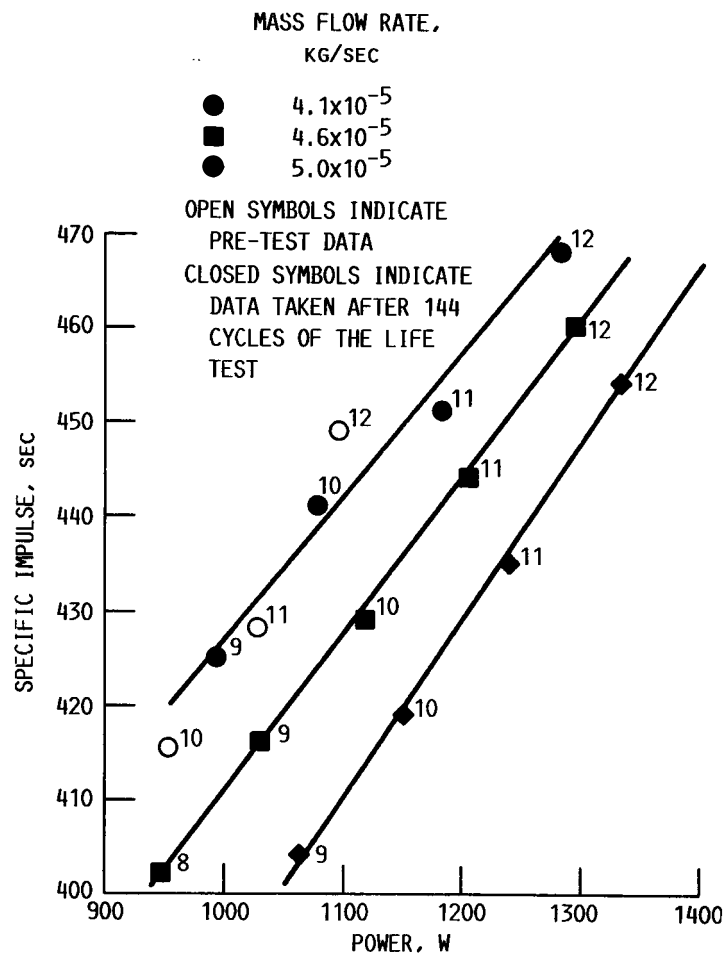
FIGURE 11. - SPECIFIC IMPULSE VERSUS POWER AT FIXED MASS FLOW RATE. NUMBERS NEAR DATA POINTS INDICATE THE CURRENT LEVEL AT WHICH THE DATA WAS TAKEN.

The data in fig. 11 also show that specific impulse values in the range of 450 sec (mission average) should be attainable at current levels between 10 and 12 A. In an application with actual hydrazine, the voltage, and hence power the level, would be slightly increased (5 to 10 V) due to the elevated pressure caused by the increased enthalpy of the propellant. The specific impulse values would also increase by about 20 sec for a given power level and mass flow rate.
